CASE ARCADA II KORTTI 18-11

ARCADA II Kyläsaari, Helsinki, Finland Street and plot area construction

light weight structure utilization of surplus soils

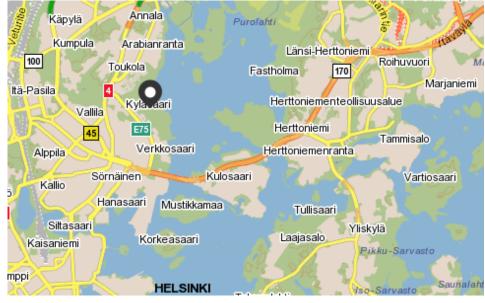
A cross section of the embankment in Arcada II and Kyläsaarenkuja illustrating the method applied. The aggregate removed from the area was replaced with stabilized clay which constitute a light weight structure.

Advantages of stabilization The unit weight of the stabilized clay is considerably smaller than the unit weight the aggregate filling submerged in the groundwater. The replacement of the aggregate with stabilized clay has allowed for considerable lightening of the structure has decreased the lateral movement. In the same way, it was possible to utilize plus soft clays which otherwise would have to be transported to soil landfill. Project timetable 12/2010 - 08/2011 mass stabilization Volumes and dimensions The amount of the mass stabilized clay − approximately 32 000 m³ Geology and stabilized material The water content of the stabilized surplus clay w ≥ 80-90 %. The unit weight for water content in question γ _w ≤ 15 kN/m³ (required). Other requirements concerstabilized clay: clean (environmental requirements) and no cobbles allowed. Target strength of the stabilized material At the depth from ground surface to level -4 τtarged ≥ 40 kPa and at level -4 to -5 τtarged ≥ 80 kPa Binder(s) Cement 100 kg/m³ Laboratory and field tests Index and stabilization tests performed in the laboratory, stabilization tests carr out with the use of various binder mixture combinations. Quality control sounding in the basins (column penetrometer) in various stages of the work. During sound tests, the observed shear strength of mass stabilization was mainly 80-300 kPa. two basins, the shear strength varied between 50-200 kPa. Other In the Kyläsaarenkuja street, steel pipe piles of large diameter were driven through the mass stabilized layer. Piling trough the stabilized layer succeeded well. Long-term follow-up and	General information	Subgrade filling failed and the big part of the aggregate filling was floating on top of the clay layer. The largest thickness of the "subgrade filling" is more than 20 m. In the vicinity of the filled area, there are mainly 2-5 m thick filling layers constructed directly on top of compressible soft layers of clay and gyttja. In order to curb the lateral movement, the thick layers of filling were lightened by digging away the original filling to the level of -5 and filling the pit with soft surplus clay which was subsequently stabilized there. The lower excavations carried out in order to remove contaminated filling were also filled with surplus clay which were stabilized afterwards.
