<p>SÖRNÄISTEN RANTA Sörnäinen, Helsinki, Finland Construction of a parking area on a sea fill</p>	<p>Key words: Contaminated sediment, Sea area filling, Sea fill, Mass stabilization</p>
<p>General information</p>	<p>The coastal neighbourhood of Sörnäisten ranta in Helsinki is an old city sector of industrial and harbour area. Nowadays these activities have been replaced by residential building and other city activities, and the infrastructure of the area has been improved after the coastal construction with mass stabilization in 1998. Many coastal constructions have been carried out by dredging sediment (mud) from the sea bottom and replacing it with frictional materials (e.g. blasted rock). In some cases, the dredged sediment has been considered unsuitable for any kind of construction purposes and transported to deposit areas. In the Sörnäisten ranta case the relocation of dredged sediment was not allowed due to its contamination. Instead, it was decided to reuse the contaminated dredged sediment in the coastal structure of the new shoreline of Sörnäisten ranta.</p>

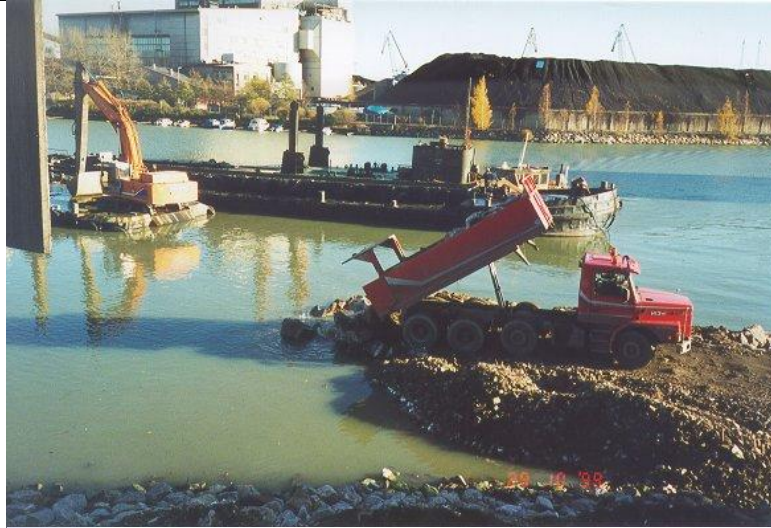
Dredging and building of the edge embankment

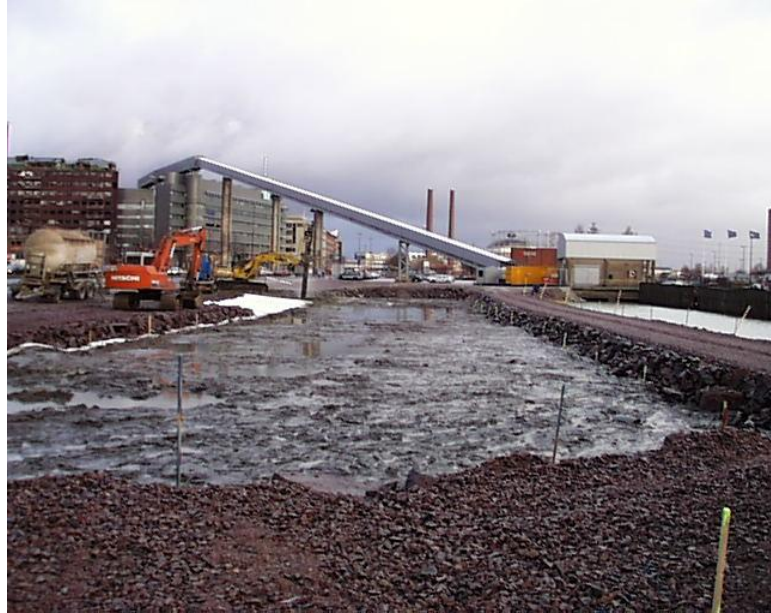
Mass stabilisation work and construction of the compacting layer

<p>Advantages of stabilization</p>	<p>For two major reasons it was necessary to stabilise and solidify the sediment. Bearing capacity had to be improved in order to avoid stability problems and settlements. Also, any future leaking of contaminants to the environment had to be avoided. With mass stabilization both of these issues could be dealt in cost-efficient way.</p>
<p>Project timetable</p>	<p>1999-2000</p>
<p>Volumes and dimensions</p>	<p>Approximately 6800 m<sup>3</sup> volume was stabilized.</p>
<p>Geology and stabilized material</p>	<p>Contaminated dredged sediment (mud) containing heavy metals, PCB and oils. Very high water content.</p>
<p>Target strength of the stabilized material</p>	<p>Shear strength 30 kPa</p>
<p>Binder(s)</p>	<p>Rapid cement 110 kg/m<sup>3</sup></p>
<p>Laboratory and field tests</p>	<p>Column penetrometer and vane penetrometer tests after construction.</p>
<p>Other</p>	<p>-</p>

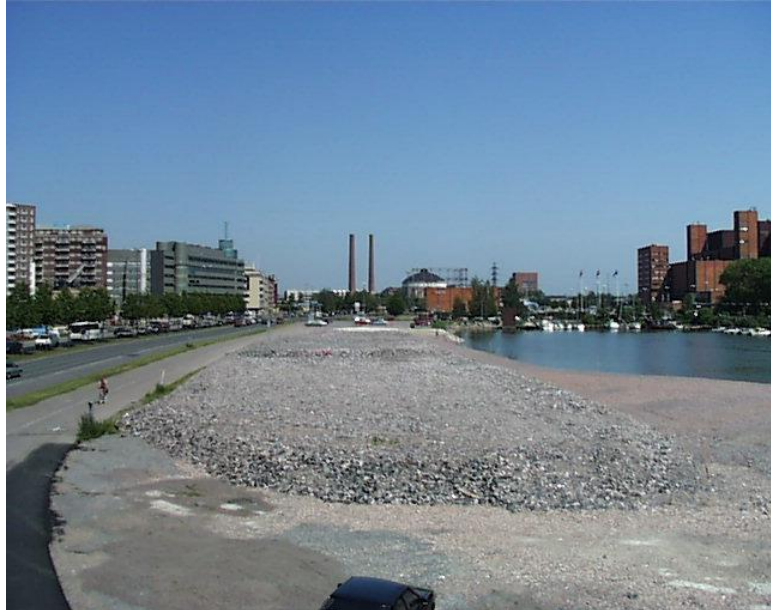
Preload embankment on top of the stabilized area
